Maine Prepares Conference
Augusta Civic Center
Day One
April 19, 2016, 3.30-4.10pm

Maine's Dam Safety Program

Maine Dam Safety Program, Office of Dam Safety, Maine Emergency Management Agency (MEMA)
Maine Department of Defense, Veterans and Emergency Management (MDVEM)
45 Commerce Drive, Augusta, ME 04333. Telephone 207-624-4400

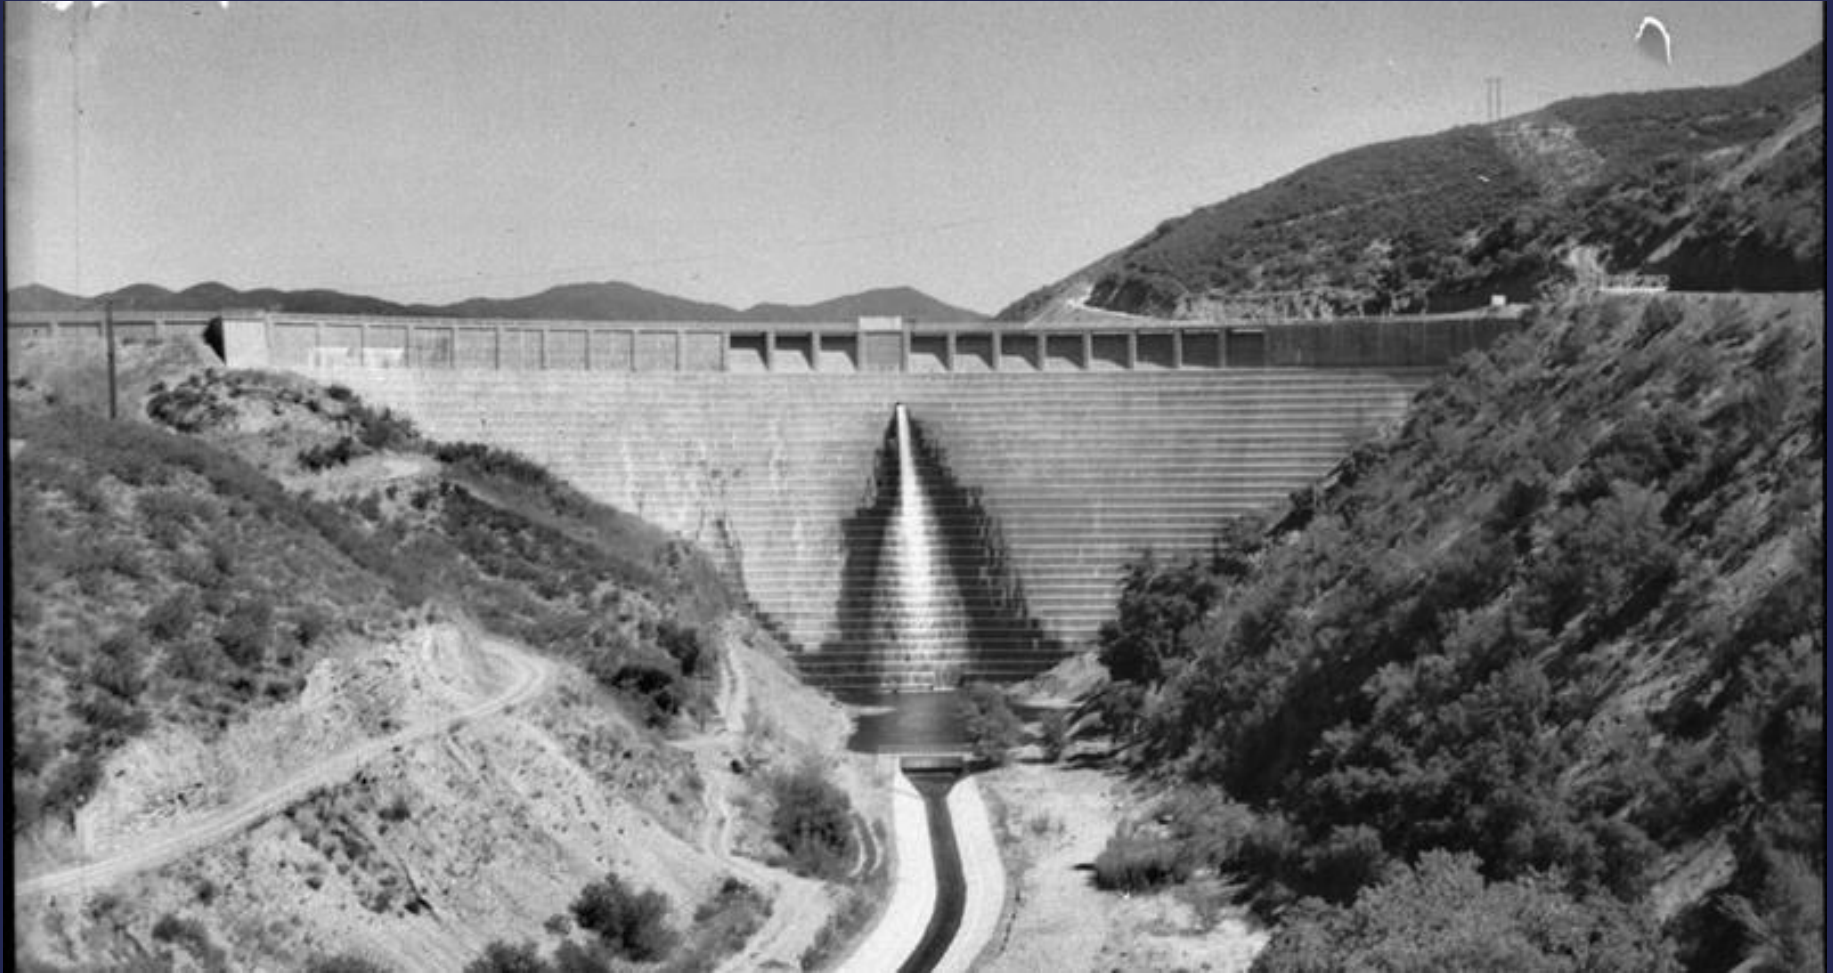
St Francis Dam – 1928 – Concrete Mass Gravity

205 feet high, 1225 feet long and 160 feet thick at the stream level.
175,000 cubic yards of concrete, build in a year at a cost of \$1,250,000.

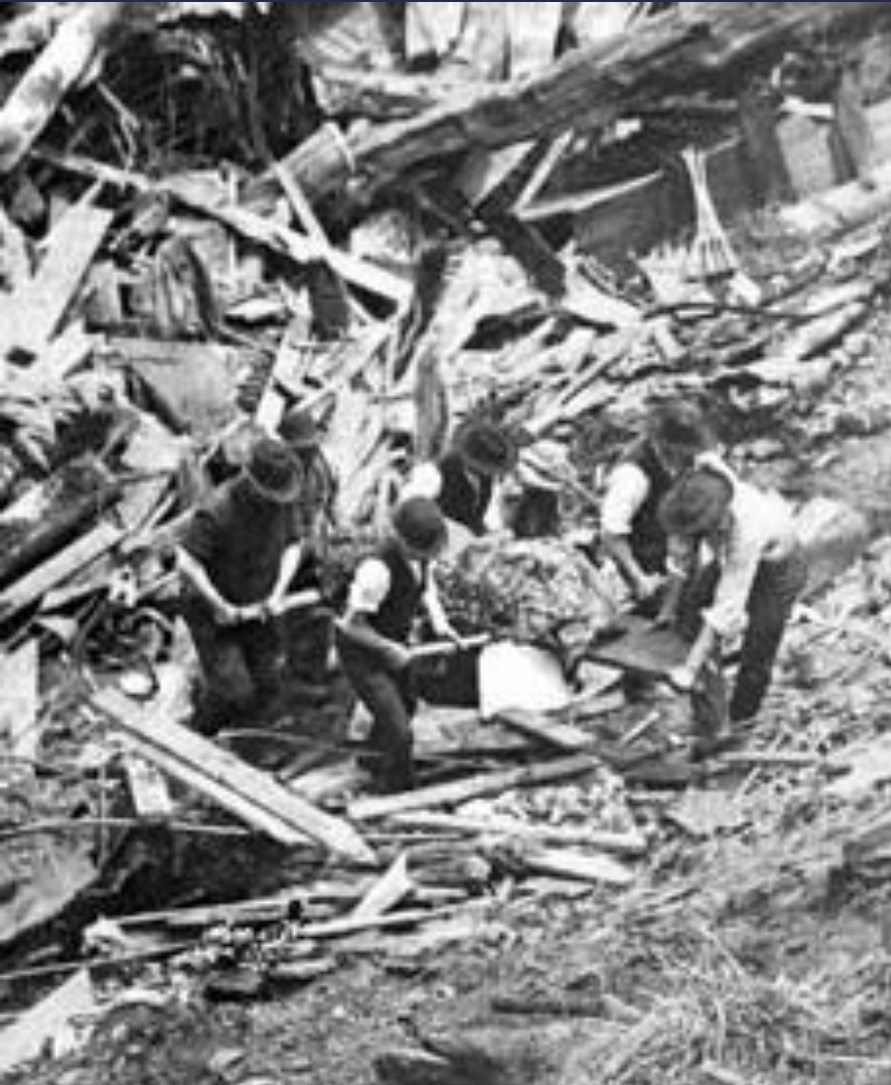
Southfork Dam failure - 1889. Overtopping caused breach. Johnstown was flooded in 30 minutes. The worst disaster in U.S. history at the time. Relief efforts were the first major actions of Clara Barton and her newly formed American Red Cross

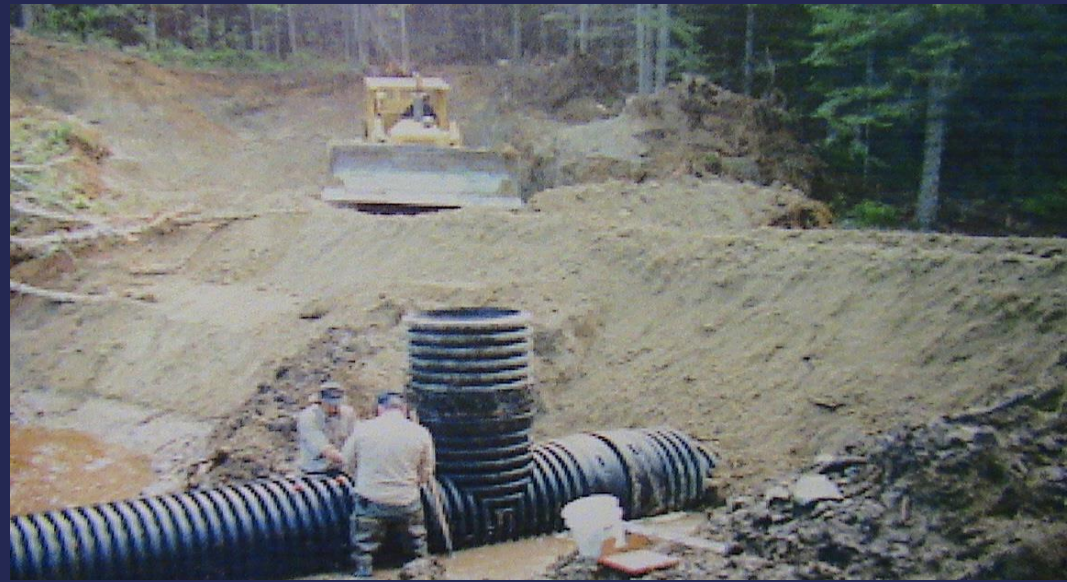
Owens Marsh Dam Under Construction

- 8/2/96 IFW built 10' high, 30' wide, 120' long, earth dam to operate 4' deep, to restore a historic lake. Volume earth 370 cy from old dam plus 490cy. USACE approved plan. No site investigation, design details, specs or as-built records found.

- Principal spillway; "Ducks Unlimited" design of PVC pipe. Control; a) stop-logs inside riser, b) beaver control.

- IFW memo 8/16/200 mentions 6-10 cy "native clay" placed around "HiCore" PVC pipe somewhere between stand pipe and outlet.

- Emergency spillway - 12' wide , 12" deep, open channel near right abutment over the top of right dike.

- In 1996 IFW hired a backhoe and bulldozer and re-constructed dam. Specification included; excavation to "hardpan and ledge", removal of old beaver dam, placement of 8"-12" mud on surface the dam after construction

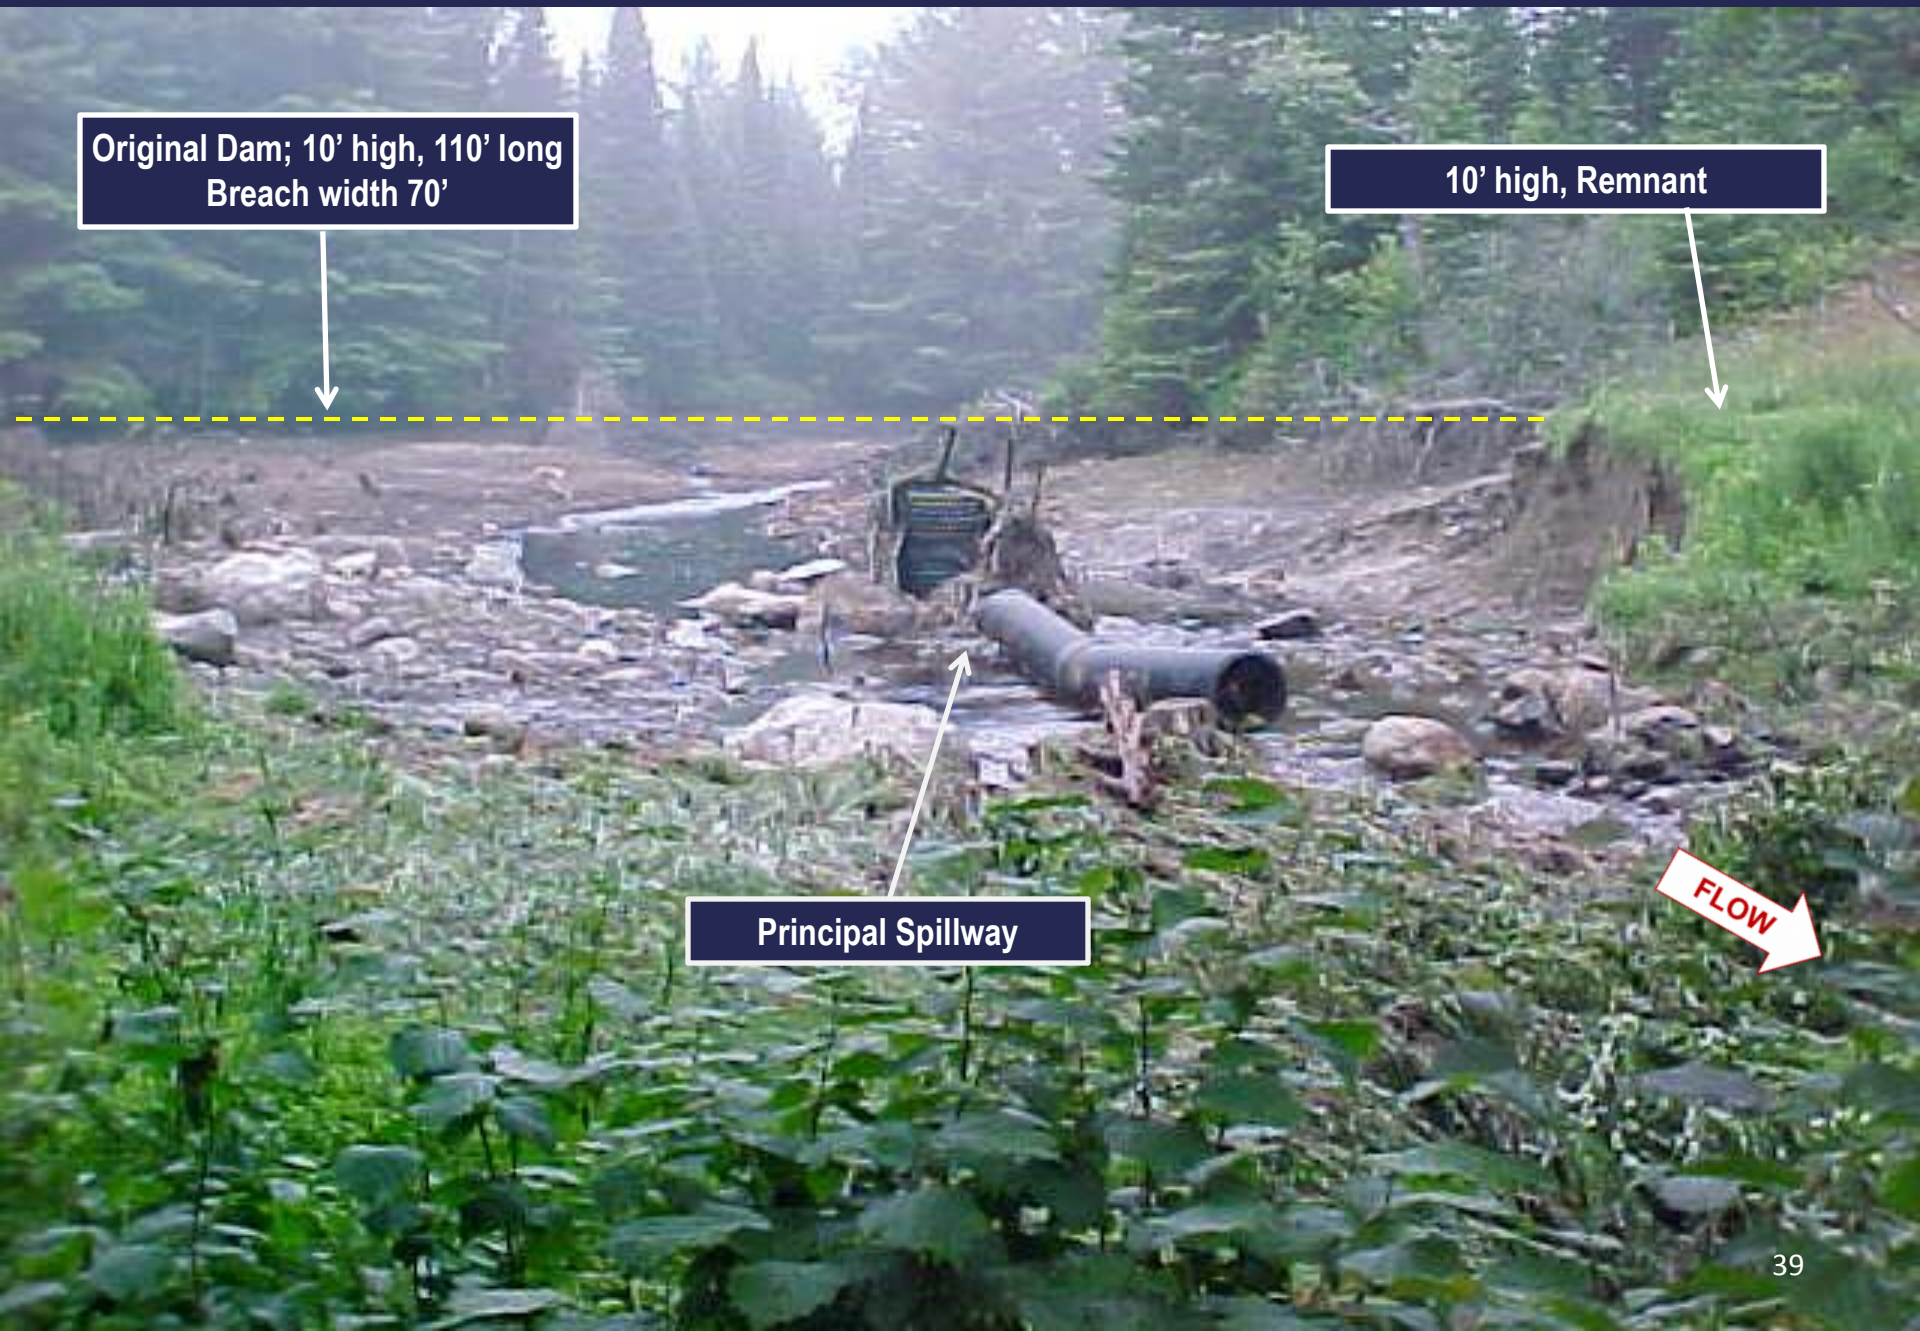
Owens Marsh Dam - Overtopping Failure July 17, 2000

Original Dam; 10' high, 110' long
Breach width 70'

10' high, Remnant

Principal Spillway

FLOW

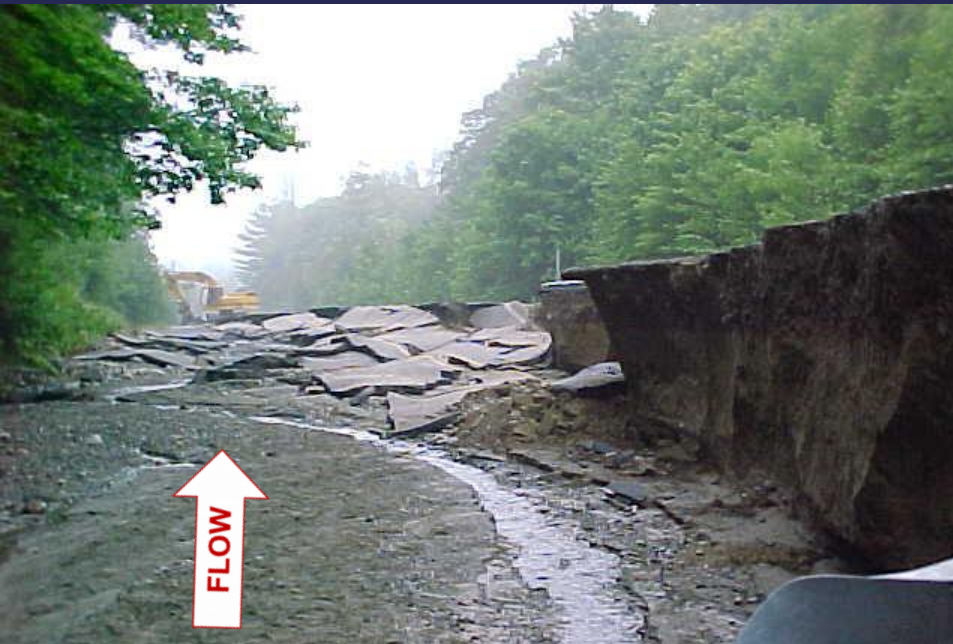
Route 16 side-drain washout near culvert 2

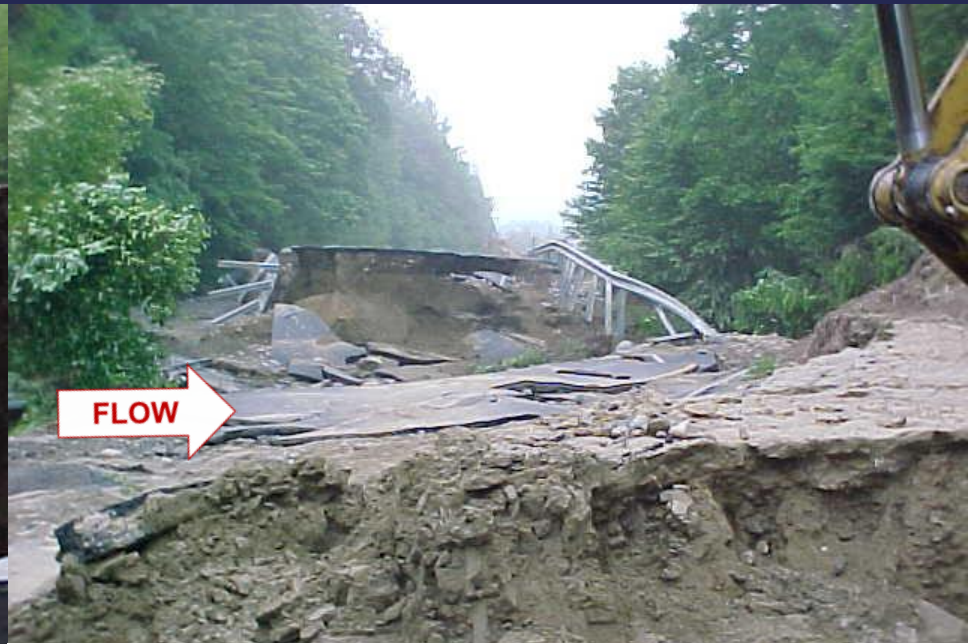
Route 16 culvert 2

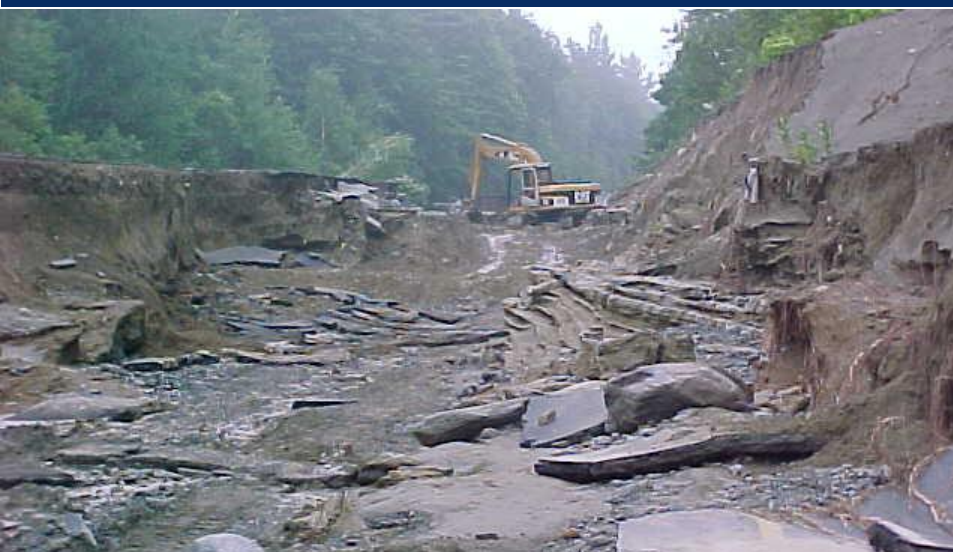
Erosion damage between culverts 2 & 3

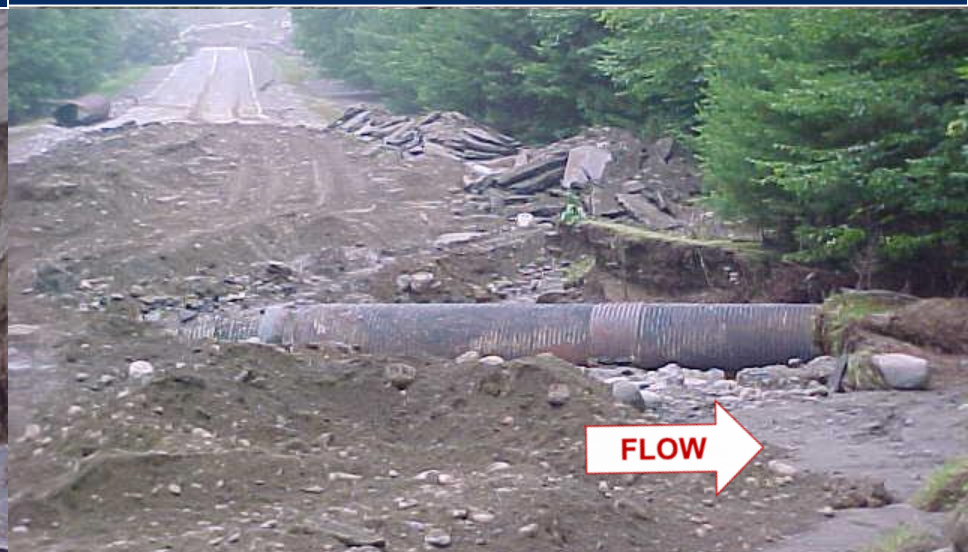
Replacement of culvert 3 by 48" cnp

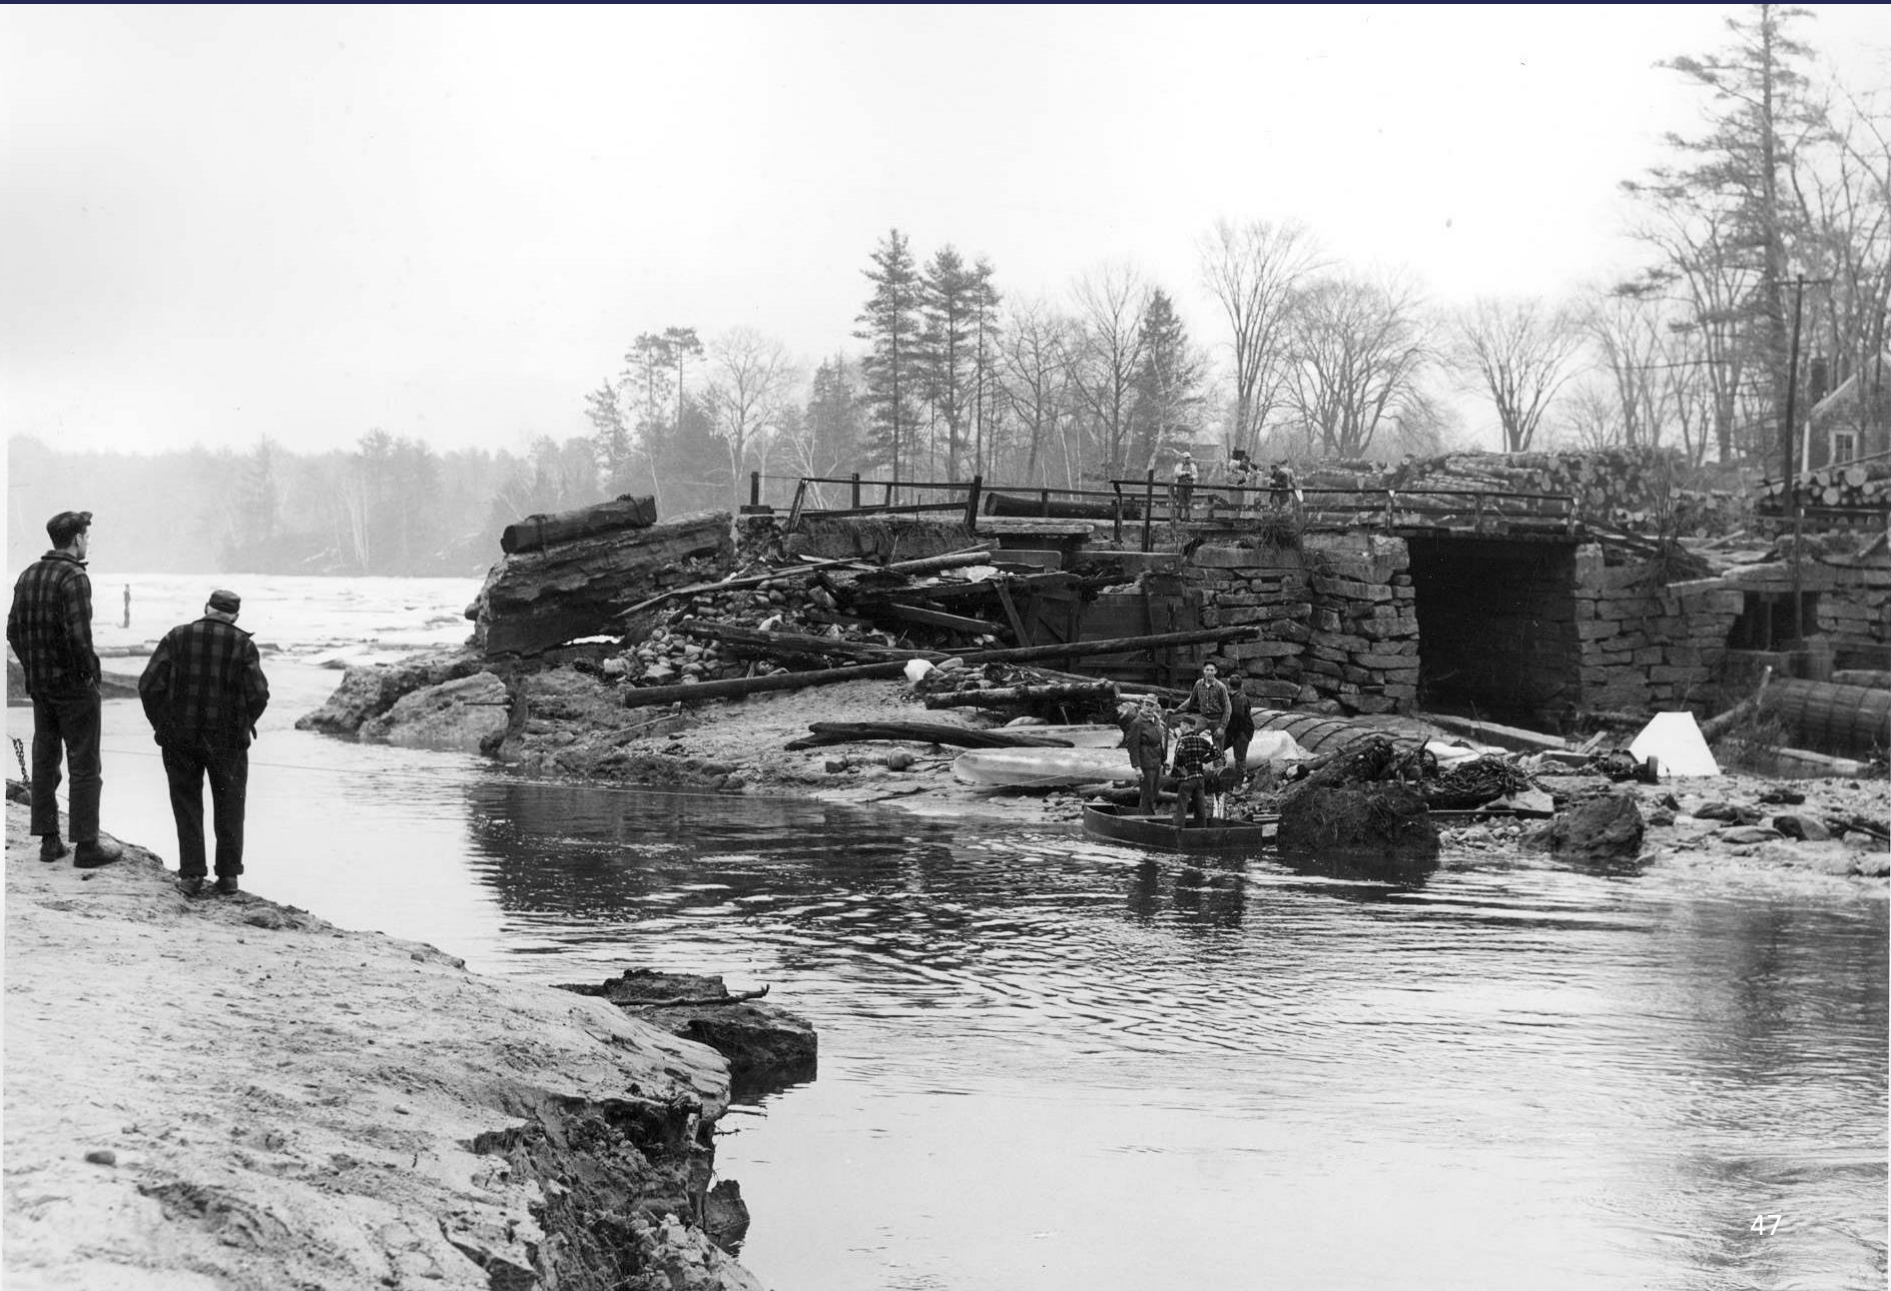
Mill Dam, Lovell, ME (1937) – Downstream Flooding

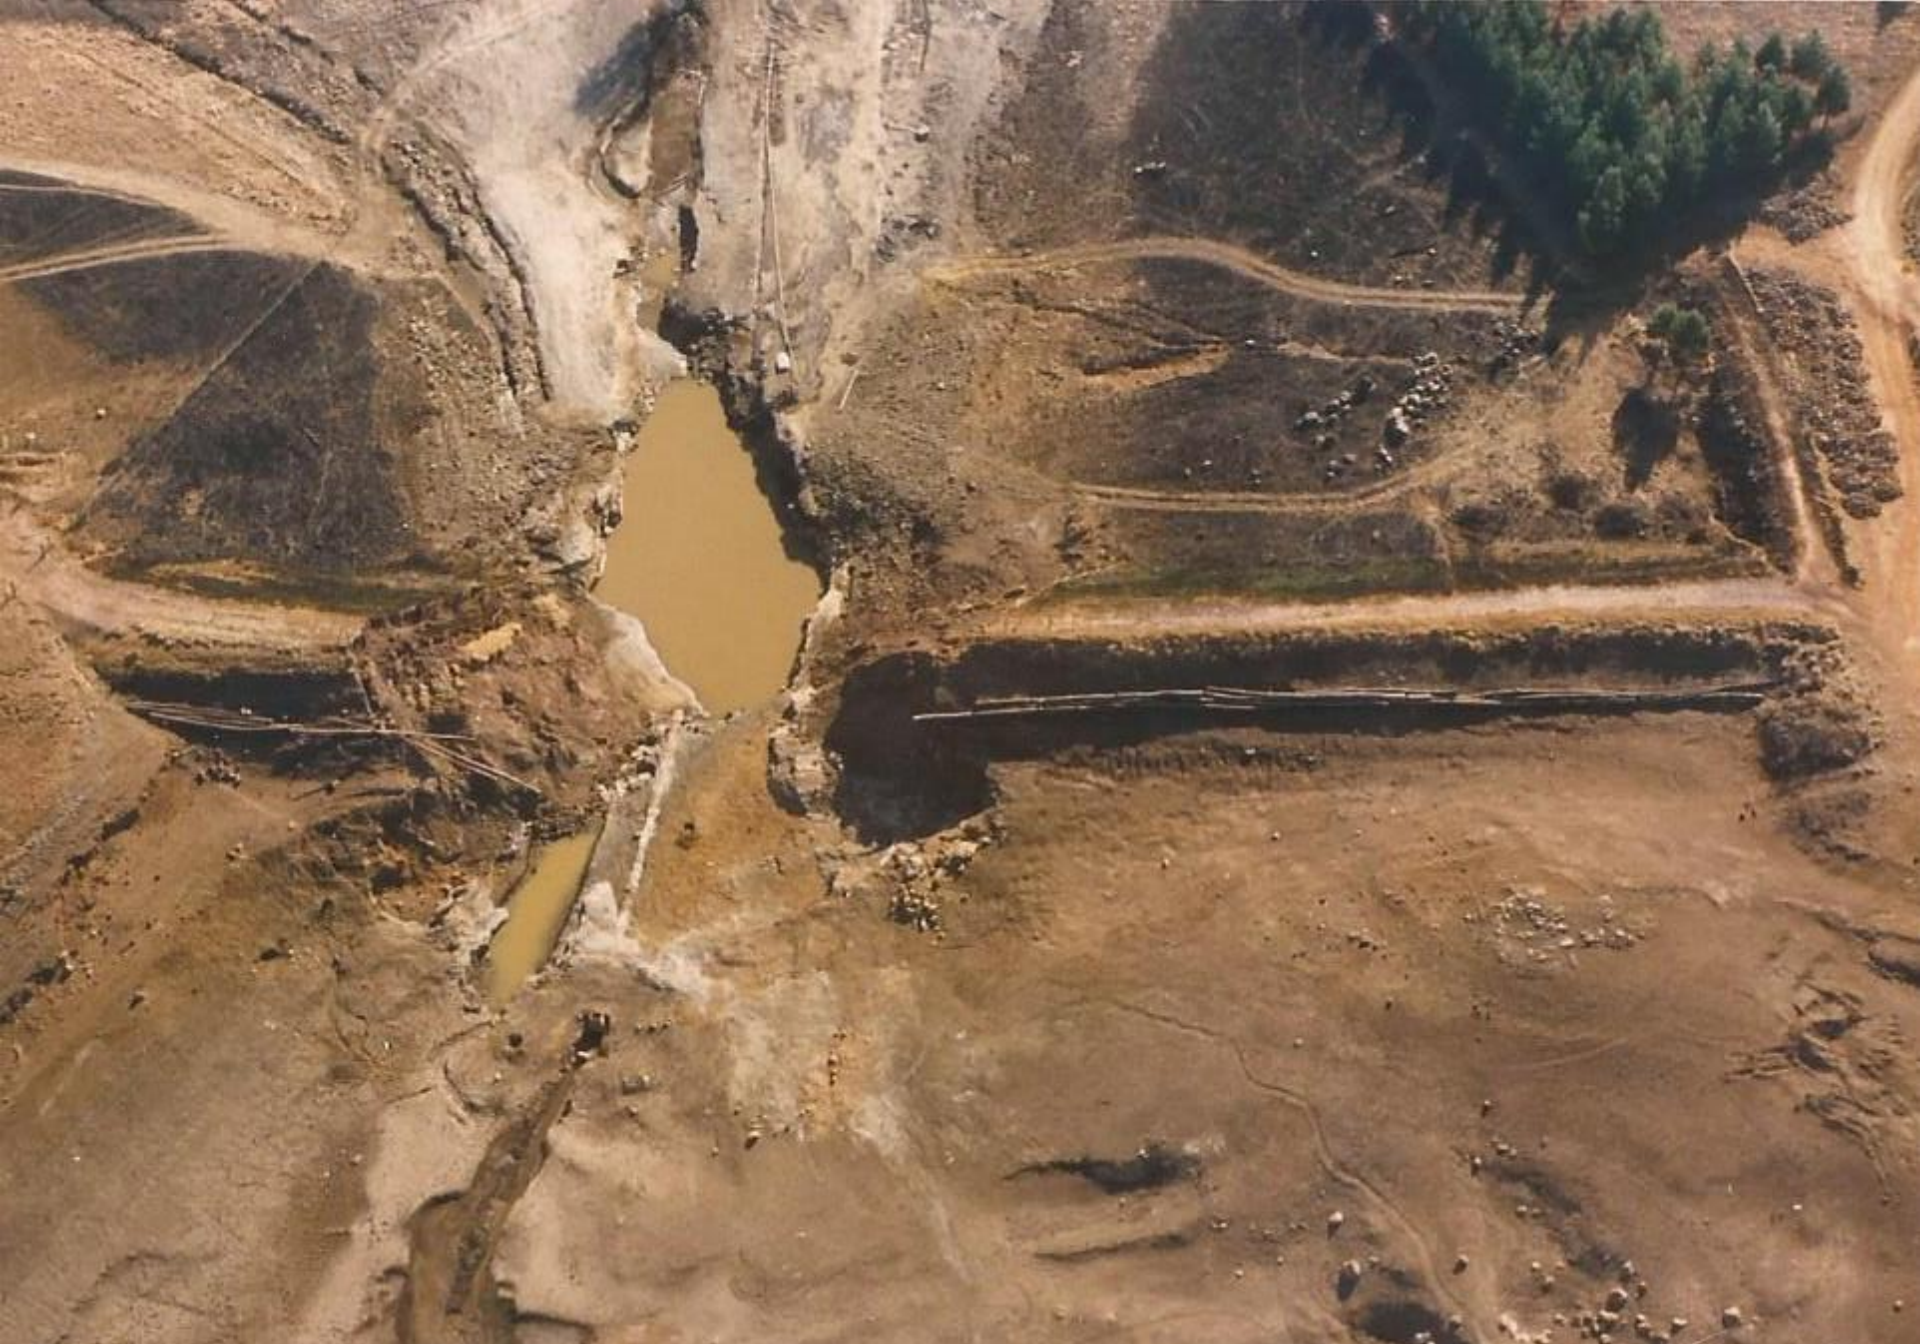
Ivanhoe Farming Company Dam. Breach caused by leakage of the outlet pipe within the dam initiating progressive internal erosion and the eventual breach of the dam

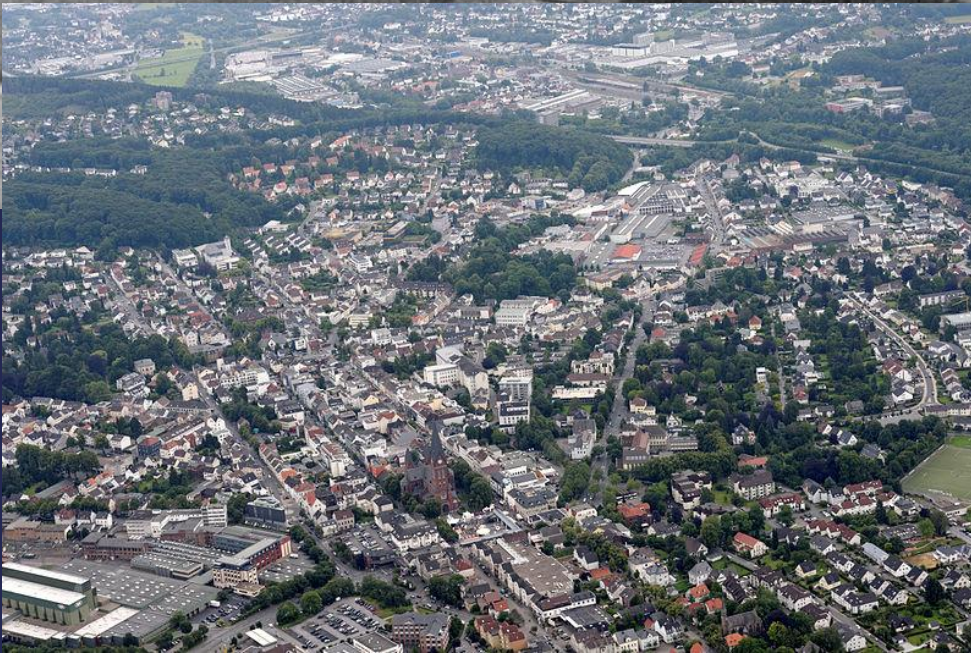
Möhne Dam, Germany

Breached by RAF Bombers 16 May 1943 using 9,250 lb bouncing bombs containing 6,600 lbs Torpex.

Breach; 260' wide, 73' high hole blown into the dam flowing at 484,000 cfs.

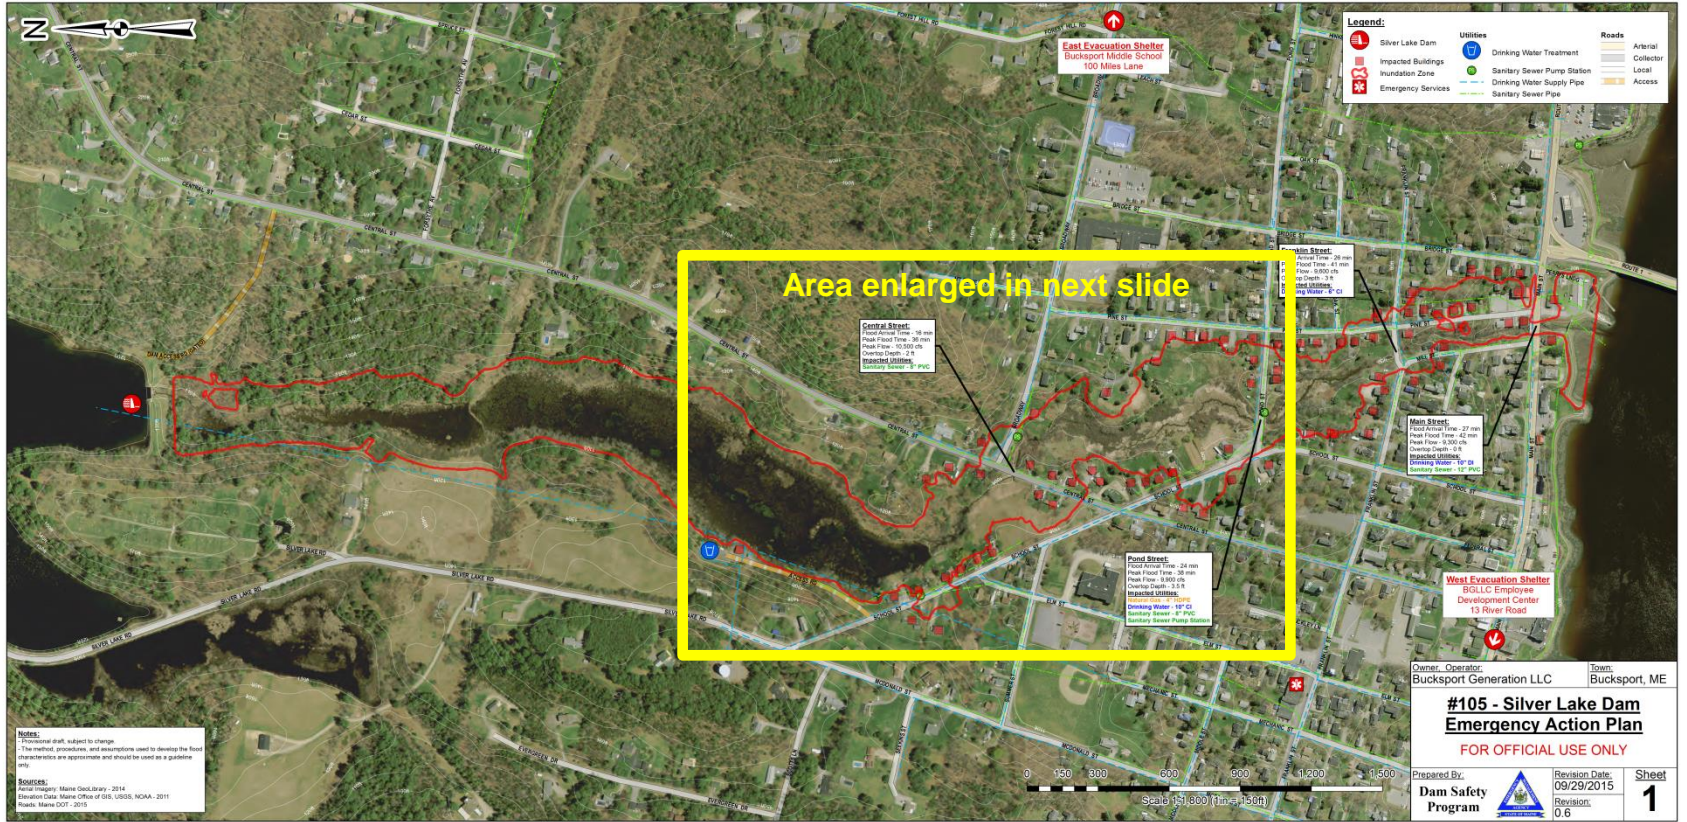
Comparing the Current and new DBIMs for Silver Lake Dam

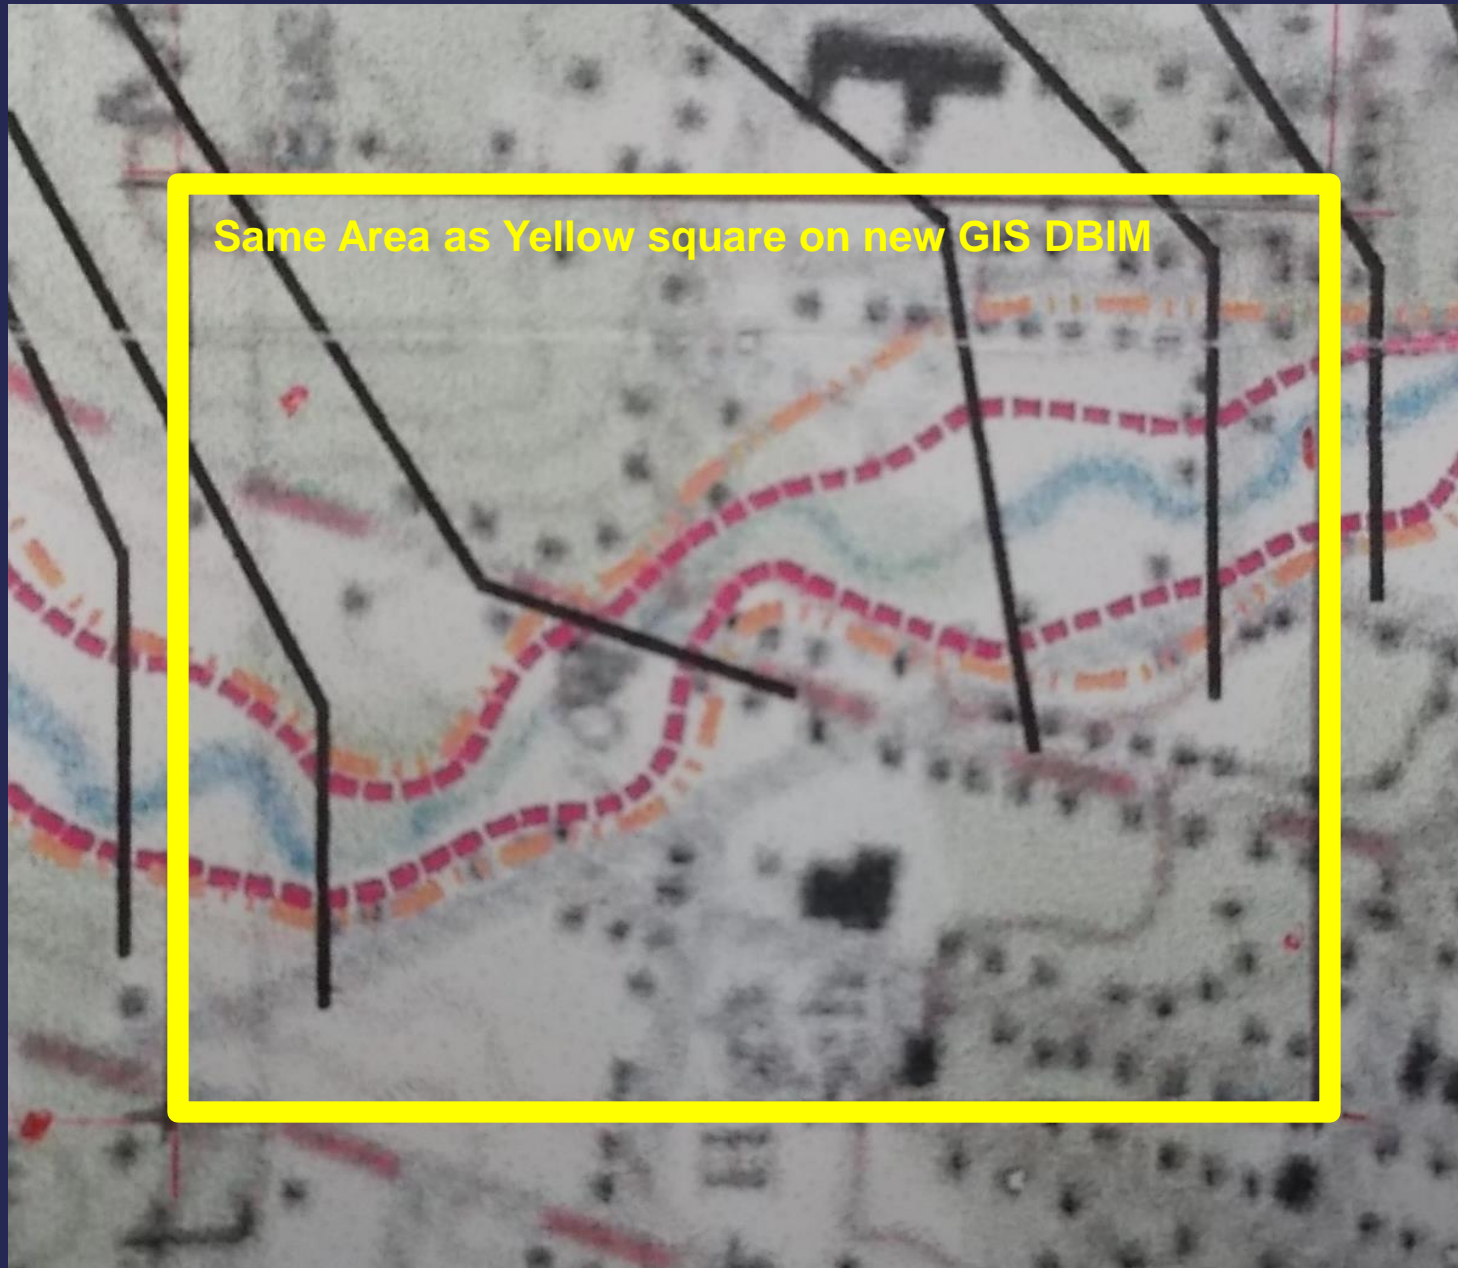
Enlargement (Yellow Square) from extant DBIM for Silver Lake Dam
